Bedrock Mapping Investigation for Groundwater Exploration Prudence Island, RI

**Northeast Water Solutions, Inc.
Exeter, RI**

Summary Report

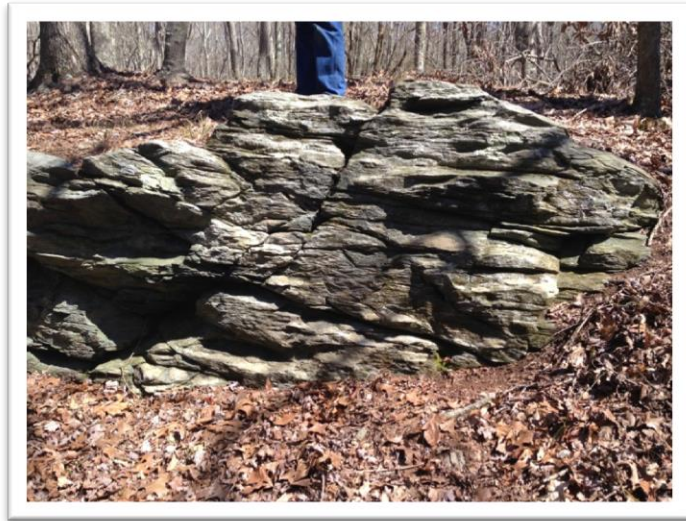
Figure 1 - Inland outcrop showing steeply dipping joint sets

Common joint data was collected to determine preferred strike orientation, dip angle and direction and degree of joint consistency across the island. Common joints are often interconnected with macro joint sets and faults, bedding planes and foliation/cleavage planes and can act as vertical transmission conduits for groundwater, especially where highly concentrated. Local divergences in common joint trends can also indicate proximity to faults and structural features of interest. Examination of Prudence Island common joints sets reveals two strongly displayed joint trends with the most prominent set striking 110 -120° and dipping steeply NNE and SSW. The second most prominent set strikes 70-80° and dips steeply NNW and SSE. Both of these sets were observed at stations throughout the middle section of the island.

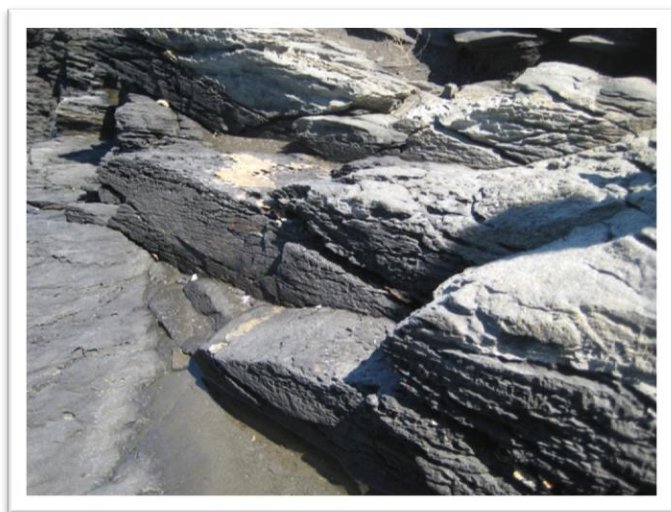
Figure 3 Shallow Qtz. filled fault on west shore offset from foliation

Fault orientation, dip angle and dip direction information were measured as high yield groundwater supplies are often found either within or in close proximity to faulted bedrock. Though faults may act as underground barriers to groundwater flow, the majority of faults are storage and transmission conduits for groundwater. While usually few in number, area faults can provide important clues regarding the preferred direction of bedrock permeability. During this time-limited mapping exercise, fault features were found only along the western side of Prudence Island, striking N–NNE and dipping E-ESE at low angles. Fault
